National Museum of Somalia, Mogadiscio: Roof Restoration Project

by
Oguz Janos Lengyel

NATIONAL MUSEUM OF SOMALIA,
MOGADISCIO :
Roof Restoration Project

Technical Report
RP/1981-1983
FMR/CLT/CH/82/160(Lengyel)
1 October 1982

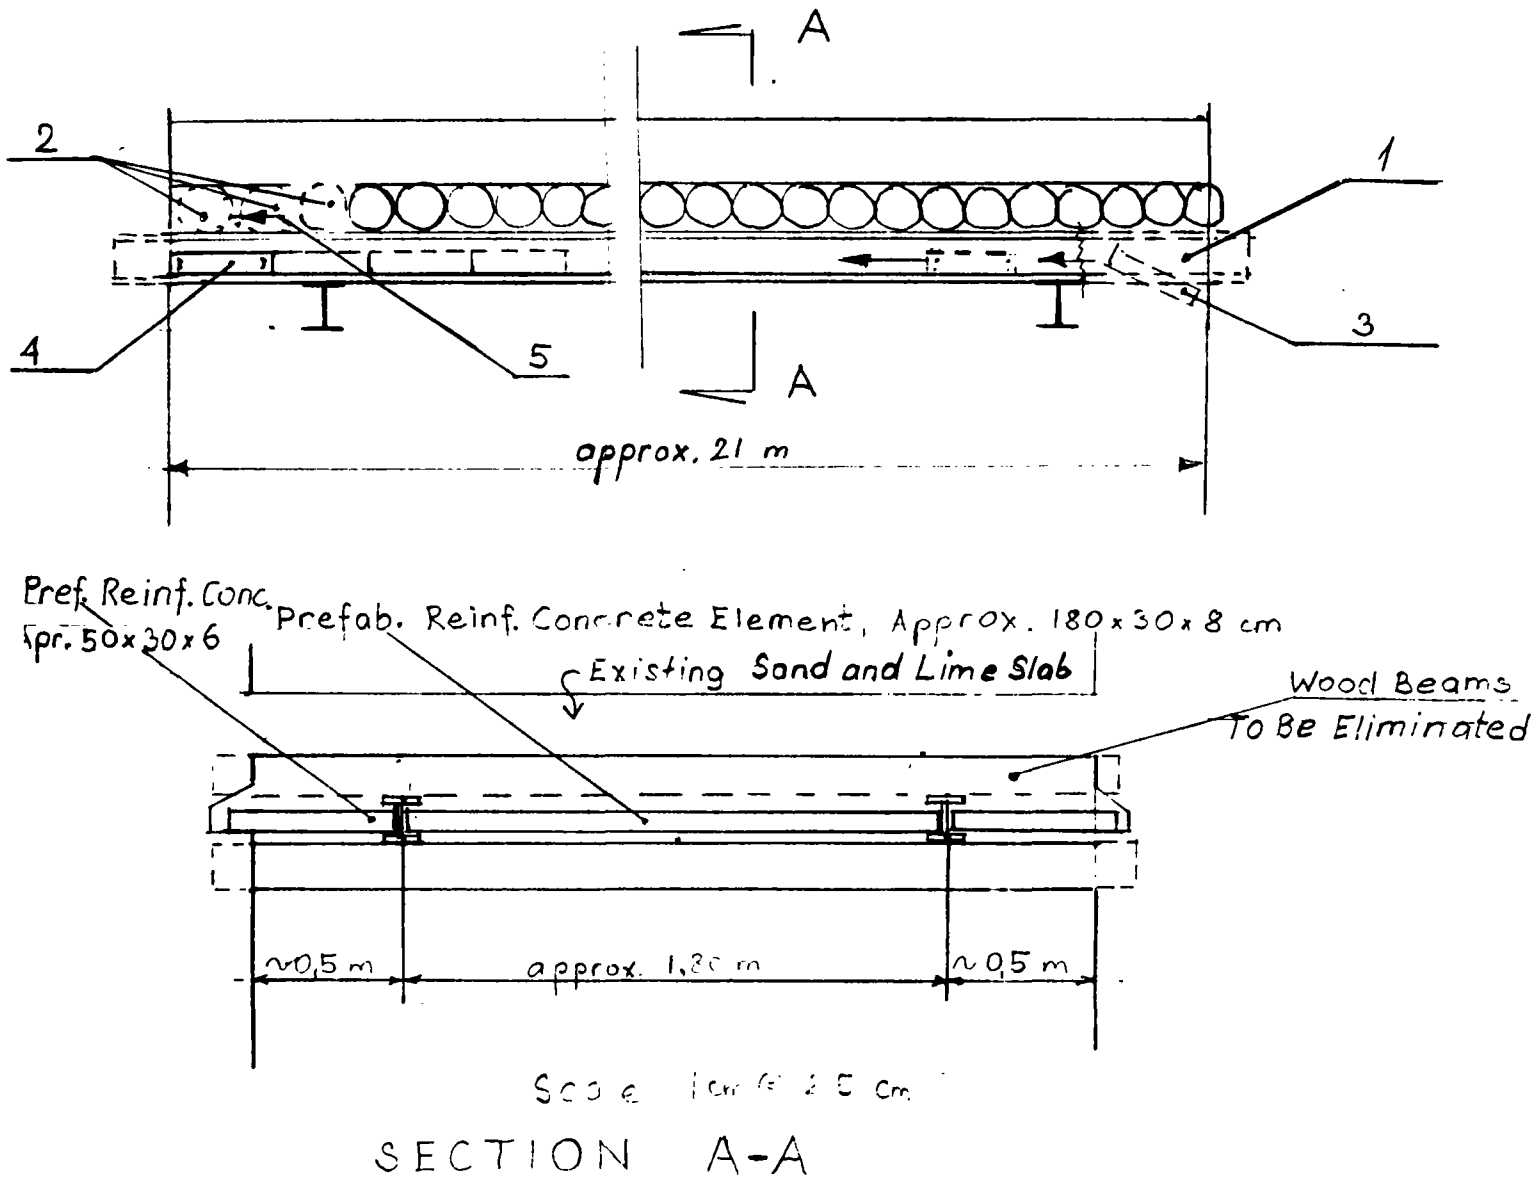
11. Recommended procedure for reinforcing and changing the ceiling on the ground floor open-sided corridor

8. The wooden ceiling in the open corridor is damaged by termites between 10% to 80% in its substance, depending on its location, so far as it is possible to judge viewed from below. The worst damage occurs in the section of the corridor nearest to the street. The wooden ceilings of the adjoining rooms and the library seem to be in better shape than the one on the corridor. Their replacement does not seem to be necessary at this time.

- i) Cut out a length of 40 cm. of existing I beams at either end of the corridor.
- ii) Eliminate 3 or 4 wooden beams at opposite end of corridor.
- iii) Slide in through cutout in I beams prefabricated reinforced concrete element.
- iv) Slide prefabricated reinforced concrete element all the way to the other end of the corridor on the lower flanges of I beams.
- v) Fill up space between element and existing floor with lightweight concrete to ensure complete support.
- vi) Install replica of wooden beam ceiling below new concrete elements to recreate original appearance.
- vii) Repeat sequence 2, 3, 4, 5 until completion.

NOTE: Verify I beams load carrying capacity before adding this additional weight. Install new cross I beam, if calculation shows it is necessary to strengthen the structure.

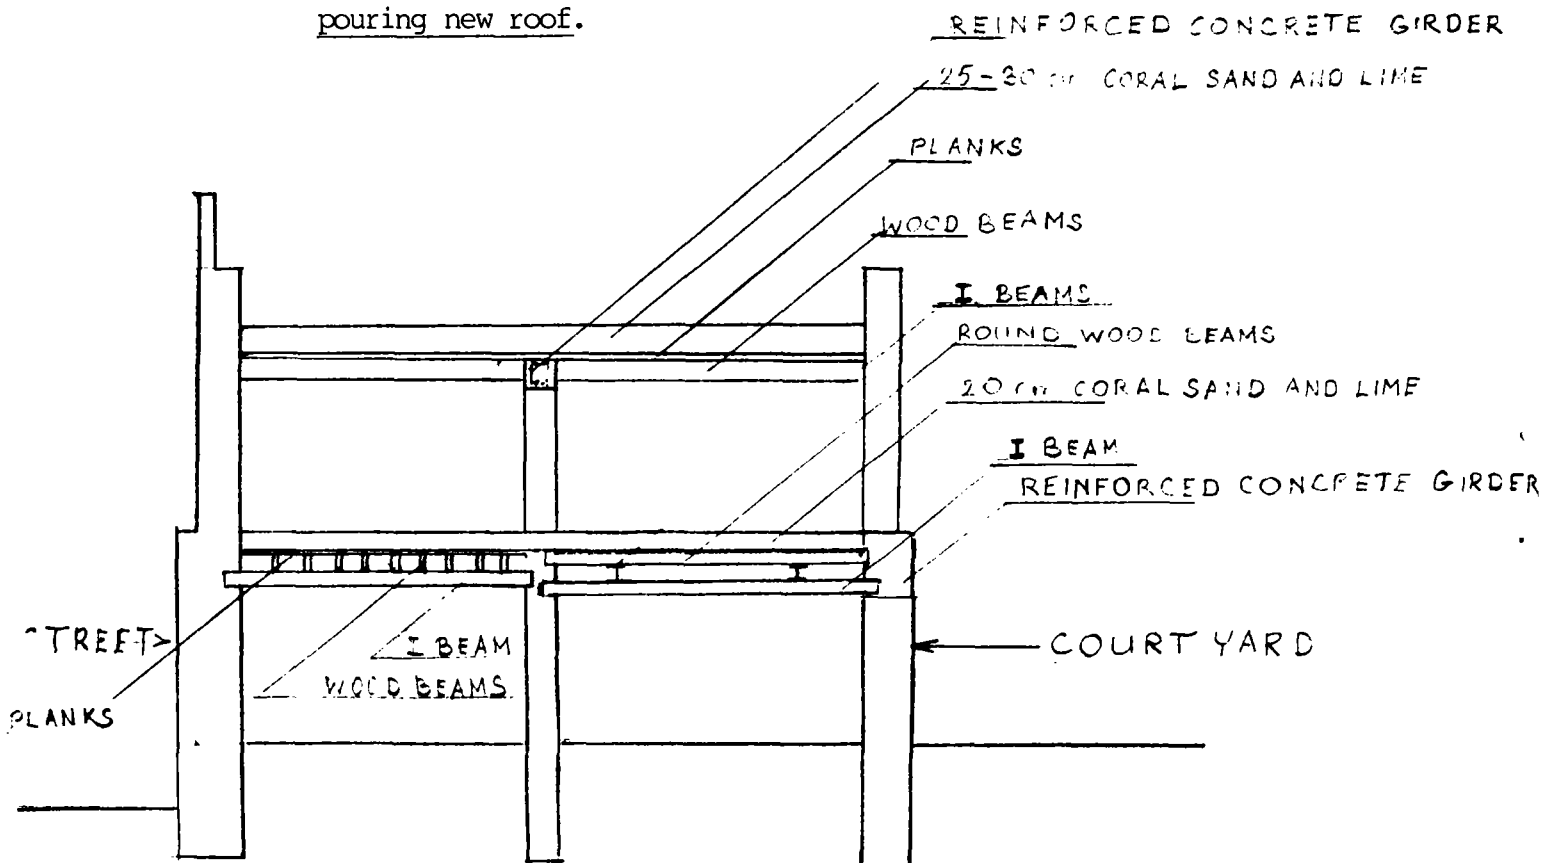
TYPICAL
CROSS SECTION

15. The roof is not waterproof. The coral sand and lime agglomerate must have been watertight in the first decades of its existence, but as it has been baked continuously by the sun, it developed cracks and was repaired again and again by layers of lime and layers of cement.

16. The only safe way of repairing the roof is by replacing it completely by a self-supporting reinforced concrete slab and waterproofing. The restoration should start with the concrete roof and proceed towards the interior in order to provide protection for the building, before carrying out the restoration of the interior.

19. The wooden beams and the planking have to be replaced partially or completely, depending in what condition they appear to be when the roof above them will be demolished. If they are to be reutilized, they should be chemically treated against termites. Any new wood in the restoration should be termite-resistant. The composition of the roof should be as on page 6.

- i) Erect temporary protection over a section of the roof.
- ii) Break up roof on a section of not more than 5 metres.
- iii) Dispose rubble through chute on street side.
- iv) Clear and examine surface of wooden planks after eliminating rubble.
- v) If wooden elements are not in perfect condition, mark them below; from the inside of the building, but do not remove yet.
- vi) Paint or spray twice all wood with anti-termite chemical solution from roof.
- vii) Cover wood with protective waterproof sheeting.
- viii) Place reinforcing steel and pour concrete and proceed to next section.
- ix) After curing concrete, place 10 cm. thick pumice heat insulation; (when the whole roof is finished).
- x) Place paper vapour barrier.
- xi) Lay two-ply bituminous felt waterproofing.
- xii) Only now remove damaged wooden elements from inside and replace them with new ones after anti-termite treatment.
